Figure A-9 VISUALLY OBSERVED RING IMPERFECTIONS

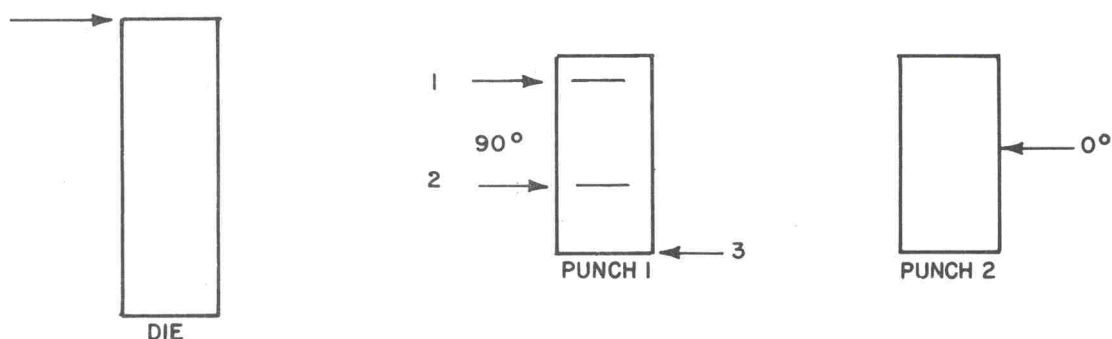
Die Outer Ring (A)

At 0 degrees the deep notch is approximately $\frac{3}{32}$ of an inch wide by $\frac{1}{8}$ of an inch long by $\frac{1}{64}$ of an inch deep. The other two notches are small and not deep enough to measure.

Punch No. 1 Outer Ring (A)

This ring has two fine lines as shown by arrows 1 and 2. These lines, as well as the spot No. 3, are not scratches or notches made after machining. They appear to have been there before machining. However No. 1 is a fine line $\frac{5}{16}$ inch long, No. 2 is $\frac{1}{32}$ inch wide and $\frac{7}{32}$ inch long, and No. 3 is $\frac{1}{32}$ inch wide by $\frac{3}{8}$ inch long.

Punch No. 2 Outer Ring (A)

The outer ring has a notch at approximately 45 degrees from its axis. The notch measures $\frac{7}{16}$ inch long, $\frac{1}{4}$ inch wide, and no more than 0.003 inch deep. A strain gage was mounted at 0 degrees near the notch and three others at 90, 180, and 270 degrees from the first one.

All three were stoned and the edges smoothed out before assembly.
