Figure A-9 VISUALLY OBSERVED RING IMPERFECTIONS

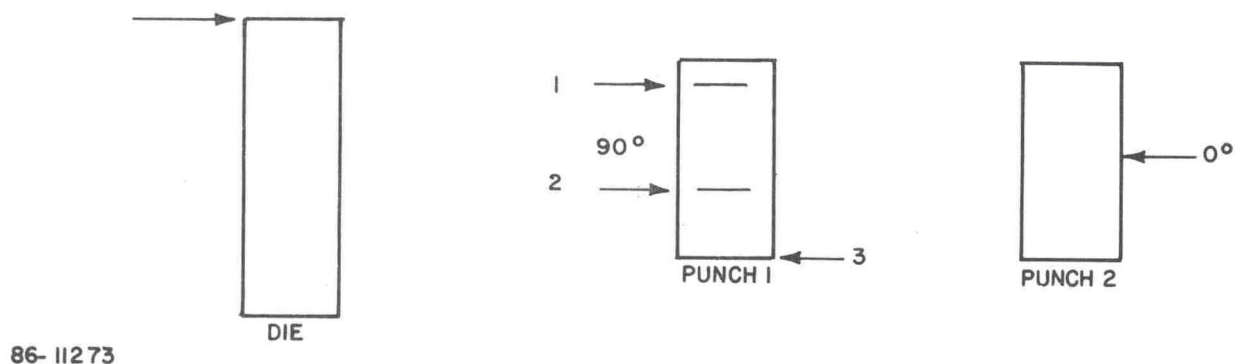
Die Outer Ring (A)

At 0 degrees the deep notch is approximately $3/32$ of an inch wide by $1/8$ of an inch long by $1/64$ of an inch deep. The other two notches are small and not deep enough to measure.

Punch No. 1 Outer Ring (A)

This ring has two fine lines as shown by arrows 1 and 2. These lines, as well as the spot No. 3, are not scratches or notches made after machining. They appear to have been there before machining. However No. 1 is a fine line $5/16$ inch long, No. 2 is $1/32$ inch wide and $7/32$ inch long, and No. 3 is $1/32$ inch wide by $3/8$ inch long.

Punch No. 2 Outer Ring (A)

The outer ring has a notch at approximately 45 degrees from its axis. The notch measures $7/16$ inch long, $1/4$ inch wide, and no more than 0.003 inch deep. A strain gage was mounted at 0 degrees near the notch and three others at 90, 180, and 270 degrees from the first one.

All other rings were visually inspected and no apparent nicks or notches were detected.

All three were stoned and the edges smoothed out before assembly.
