Figure A-9 VISUALLY OBSERVED RING IMPERFECTIONS

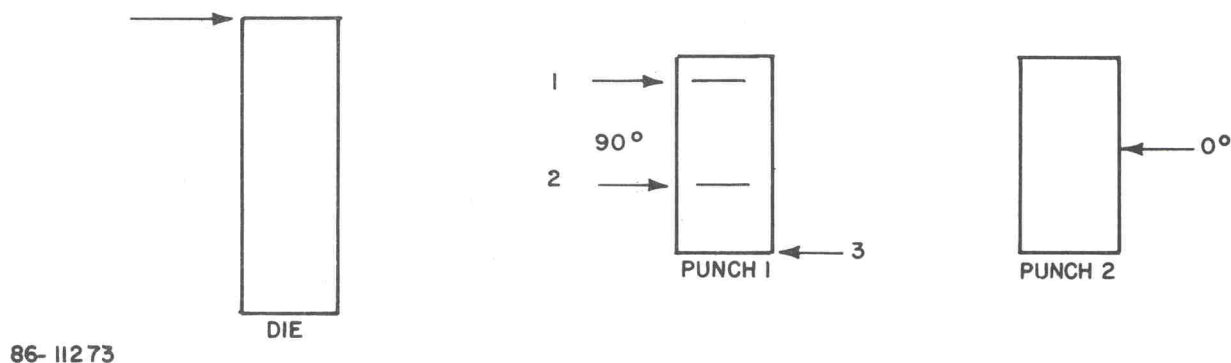
At 0 degrees the deep notch is approximately  $3/32$  of an inch wide by  $1/8$  of an inch long by  $1/64$  of an inch deep. The other two notches are small and not deep enough to measure.

No. 1 strain gage was mounted at the 0-degree point. No. 2, 3, 4 gages were placed at 90, 180, 270 degrees respectively in a clockwise direction looking in the top.

This ring has two fine lines as shown by arrows 1 and 2. These lines, as well as the spot No. 3, are not scratches or notches made after machining. They appear to have been there before machining. However No. 1 is a fine line  $5/16$  inch long, No. 2 is  $1/32$  inch wide and  $7/32$  inch long, and No. 3 is  $1/32$  inch wide by  $3/8$  inch long.

The outer ring has a notch at approximately 45 degrees from its axis. The notch measures  $7/16$  inch long,  $1/4$  inch wide, and no more than 0.003 inch deep. A strain gage was mounted at 0 degrees near the notch and three others at 90, 180, and 270 degrees from the first one.

All other rings were visually inspected and no apparent nicks or notches were detected.

All three were stoned and the edges smoothed out before assembly.
