Figure A-9 VISUALLY OBSERVED RING IMPERFECTIONS

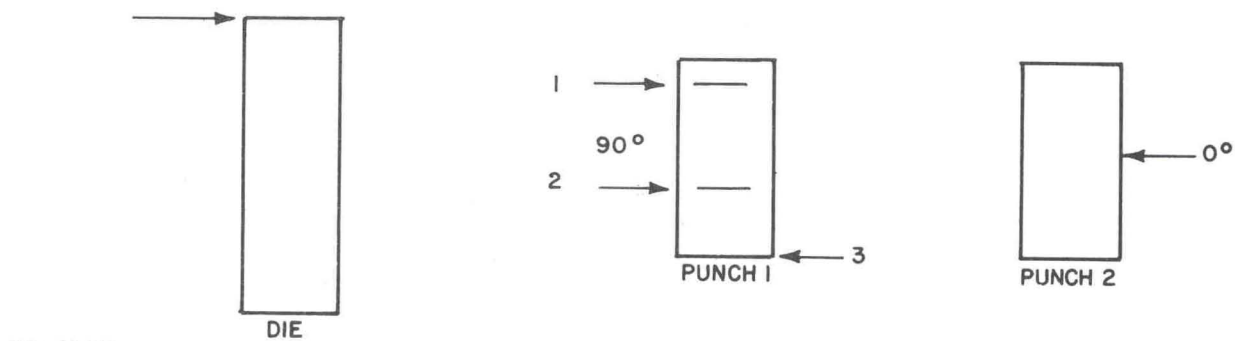
86-11273

At 0 degrees the deep notch is approximately  $3/32$  of an inch wide by  $1/8$  of an inch long by  $1/64$  of an inch deep. The other two notches are small and not deep enough to measure.

No. 1 strain gage was mounted at the 0-degree point. No. 2, 3, 4 gages were placed at 90, 180, 270 degrees respectively in a clockwise direction looking in the top.

This ring has two fine lines as shown by arrows 1 and 2. These lines, as well as the spot No. 3, are not scratches or notches made after machining. They appear to have been there before machining. However No. 1 is a fine line  $5/16$  inch long, No. 2 is  $1/32$  inch wide and  $7/32$  inch long, and No. 3 is  $1/32$  inch wide by  $3/8$  inch long.

The outer ring has a notch at approximately 45 degrees from its axis. The notch measures  $7/16$  inch long,  $1/4$  inch wide, and no more than 0.003 inch deep. A strain gage was mounted at 0 degrees near the notch and three others at 90, 180, and 270 degrees from the first one.

All three were stoned and the edges smoothed out before assembly.
