TABLE LII. SAFETY FACTORS ESTIMATED FOR THE COMPONENTS OF CONTAINER I FOR VARIOUS OPERATING CONDITIONS

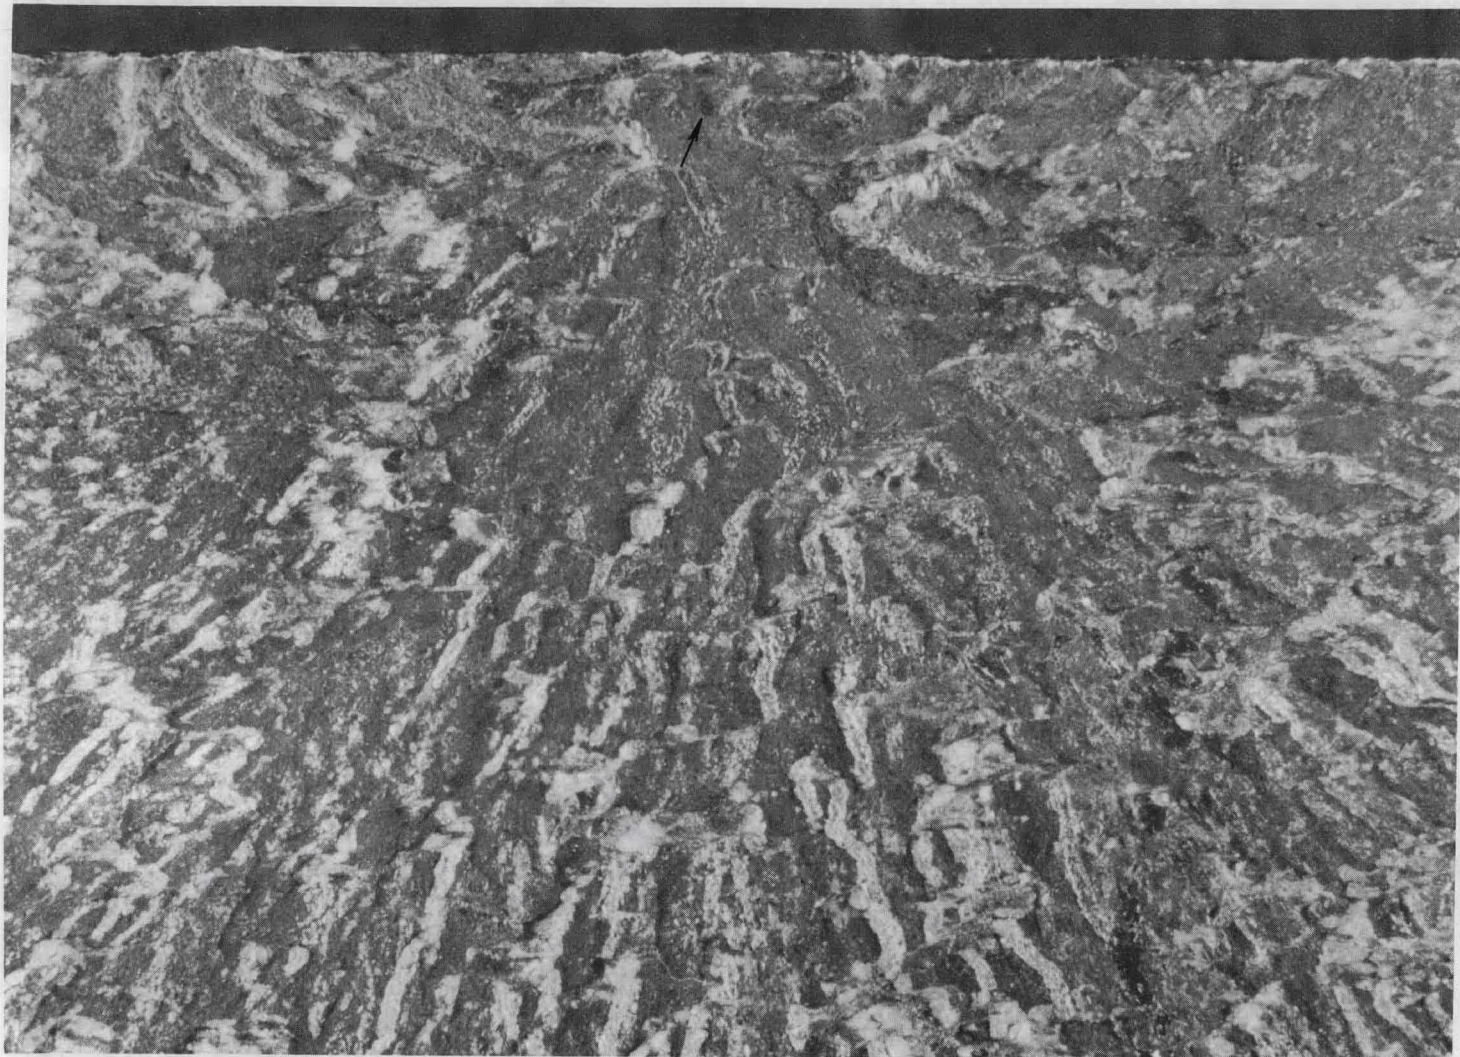
FIGURE 70. FRACTOGRAPH OF FRACTURED SURFACE OF LINER OF CONTAINER I

The liner had been made from consumable, vacuum-melted AISI-M50 tool steel. Examination of the fractured surfaces of the liner by several techniques indicates that the failure resulted from low-cycle fatigue. The failure appears to have initiated at a point near the middle of the longitudinal crack. A photomicrograph at 25X of the fractured surface at the suspected point of initiation is shown in Figure 70. It is noted that radial markings appear to emanate from a small round void indicated by an arrow. This void is approximately 0.005 inch in diameter and is located about 0.008 inch beneath the liner bore surface. The mating fractured surface contains a protrusion which appears to match the void in size, shape, and location.

The precise nature of the protrusion is not known. It is suspected that it is an inclusion, although it is unusually large for consumable, vacuum-melted materials in which inclusions generally are no larger than about 0.0005 inch. This was found to be

Arrow points to void located about 0.008 inch beneath the liner bore surface.
