## Container II

### Revised Container-Assembly Design

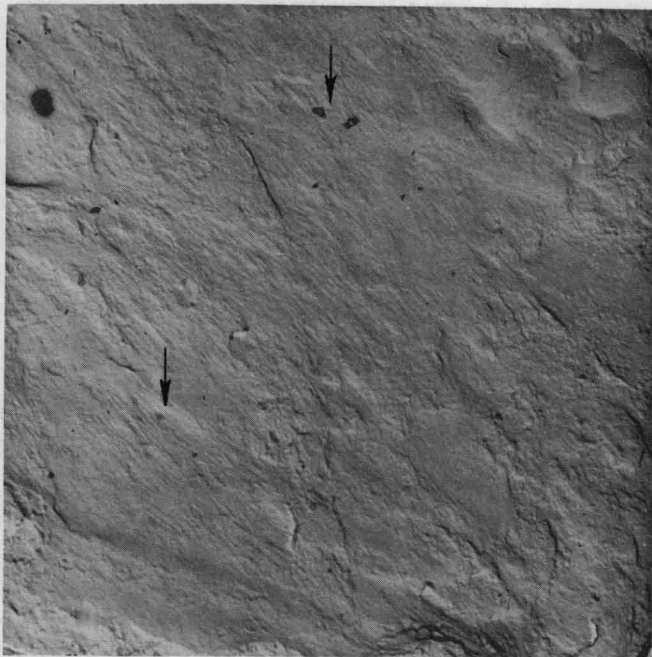
Electron microscopic fractography was employed to determine the mode of crack propagation in the vicinity of the origin. A standard two-stage plastic carbon replication technique was used to obtain replicas of an area approximately 0.1 inch<sup>2</sup> containing the above described void. Examination at a magnification of 12,200X revealed the fractured surface to be generally flat and featureless with localized regions containing very fine fatigue striations. The fatigue striations are indicated by the arrows in the electron microscopic fractograph shown in Figure 71. The small spacing of the striations suggests that crack growth may not have been due to the extrusion pressure cycles alone, but also to a vibration or pulsation superimposed on the high pressure. An obvious source of this vibration is the hydraulic pump of the press which can transmit pulsations to the liner by way of the stem and hydrostatic fluid. The extent to which such vibrations may have contributed to the rate of crack growth is not known.

FIGURE 71. ELECTRON MICROSCOPIC FRACTOGRAPH SHOWING FINE FATIGUE STRIATIONS IN LINER OF CONTAINER I

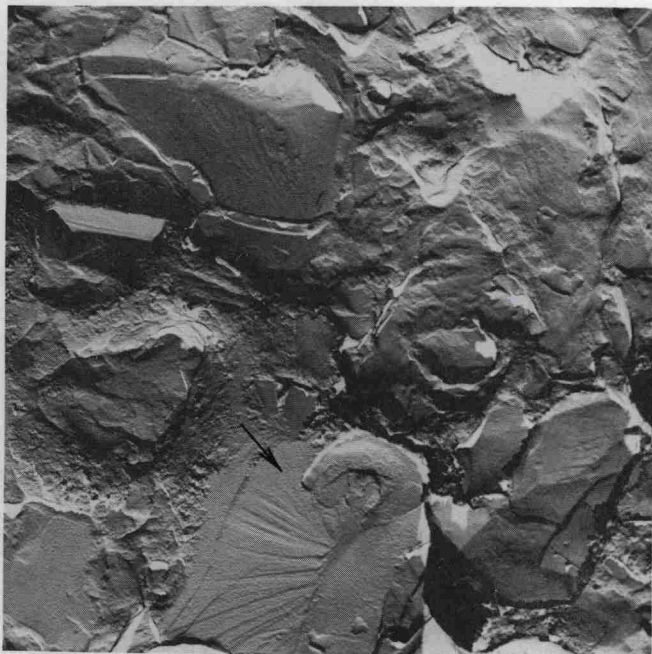
Another feature of significance is evident in the fractograph shown in Figure 72. This is the typical cleavage-type fracture (fan-like striations indicated by arrow) of undissolved carbides. This observation indicates that these particles would have accelerated growth of the fatigue crack by fracturing in a brittle manner on a single cycle of load over a distance much larger than the crack growth per cycle indicated by the very fine striations noted earlier.

FIGURE 72. ELECTRON MICROSCOPIC FRACTOGRAPH SHOWING CLEAVAGE FRACTURE OF UNDISSOLVED CARBIDES IN LINER OF CONTAINER I
