## Container II

### Revised Container-Assembly Design

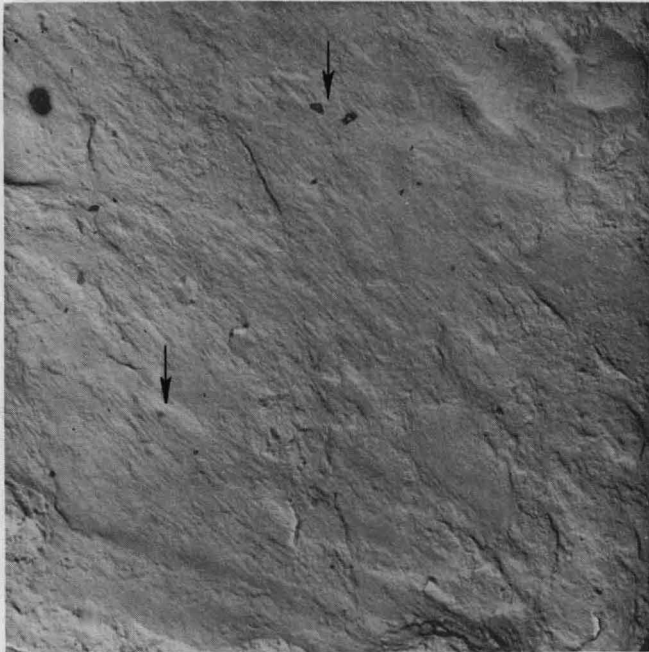
E1646A

Electron microscopic fractography was employed to determine the mode of crack propagation in the vicinity of the origin. A standard two-stage plastic carbon replication technique was used to obtain replicas of an area approximately 0.1 inch<sup>2</sup> containing the above described void. Examination at a magnification of 12,200X revealed the fractured surface to be generally flat and featureless with localized regions containing very fine fatigue striations. The fatigue striations are indicated by the arrows in the electron microscopic fractograph shown in Figure 71. The small spacing of the striations suggests that crack growth may not have been due to the extrusion pressure cycles alone, but also to a vibration or pulsation superimposed on the high pressure. An obvious source of this vibration is the hydraulic pump of the press which can transmit pulsations to the liner by way of the stem and hydrostatic fluid. The extent to which such vibrations may have contributed to the rate of crack growth is not known.

FIGURE 71. ELECTRON MICROSCOPIC FRACTOGRAPH SHOWING FINE FATIGUE STRIATIONS IN LINER OF CONTAINER I

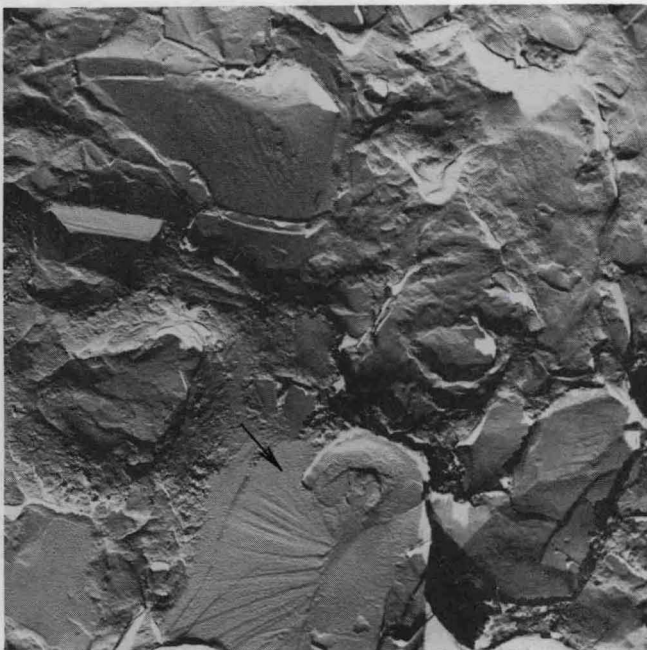
E1646E

Another feature of significance is evident in the fractograph shown in Figure 72. This is the typical cleavage-type fracture (fan-like striations indicated by arrow) of undissolved carbides. This observation indicates that these particles would have accelerated growth of the fatigue crack by fracturing in a brittle manner on a single cycle of load over a distance much larger than the crack growth per cycle indicated by the very fine striations noted earlier.

FIGURE 72. ELECTRON MICROSCOPIC FRACTOGRAPH SHOWING CLEAVAGE FRACTURE OF UNDISSOLVED CARBIDES IN LINER OF CONTAINER I
