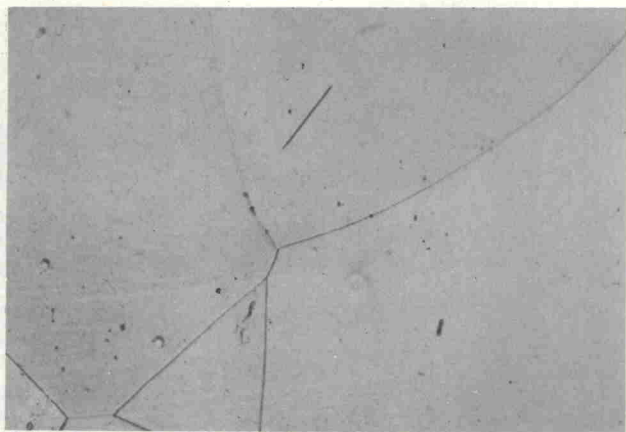
(a) 0 pressure

(b) 15,000 atm

(c) 500 atm

(d) 20,000 atm

Fig. 2—Typical structural changes along one side of original grain boundary. X100. Enlarged approximately 2 pct for reproduction
