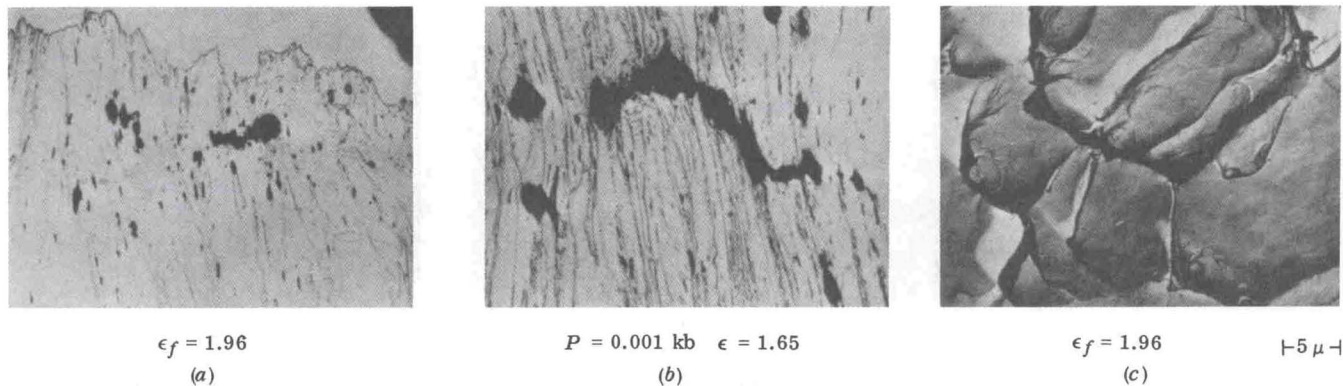
Fig. 3—Fracture in annealed 0.004 pct C material at atmospheric pressure. (a) and (b) magnification 106 times.

1) **Fracture in Annealed 0.004 pct C and Spheroidized Materials.** a) *0.004 pct C Material.* Optical and electron fractographs of the 0.004 pct C material tested at atmospheric pressure are shown in Fig. 3. As can be seen in Figs. 3(a) and 3(b), the latter of which is a specimen strained to near fracture, the fracture mechanism involves the initiation, growth, and coalescence of massive voids. The major voids are limited to the center portion of the region of greatest necking where they grow and coalesce to form a major crack. In this region the electron fractograph, Fig. 3(c), shows equiaxed dimples corresponding to the "hills and valleys" seen in the fracture surface, Fig. 3(a).

The effects of pressure upon the fracture appearance are shown in Fig. 4. There is a progressive suppression of the void growth with increasing pressure as can be seen by comparing Fig. 3(a) with Fig. 4. At a pressure of 2.5 kbars, Fig. 4(a), only a few small elongated voids are in evidence. At 15.1 kbars, Fig. 4(b), there appears to be no discernible voids. There is a concomitant progressive change in the fracture profile from the "hill and valley" type at atmospheric pressure, Fig. 3(a), to primarily a series of shear steps at 2.5 kbars, Fig. 4(a), and finally to a flat planar shear type fracture at 15.1 kbars, Fig. 4(b). Due to the small cross sectional area at 15.1 kbars, it was not possible to obtain a reliable electron fractograph. However, from the appearance of the fracture surface shown in Fig. 4(b) and the results from the materials to be subsequently discussed, it is highly probable that the electron fractograph would be effectively featureless.
