Tin-bismuth alloys

90 per cent Sn-bal Bi alloy

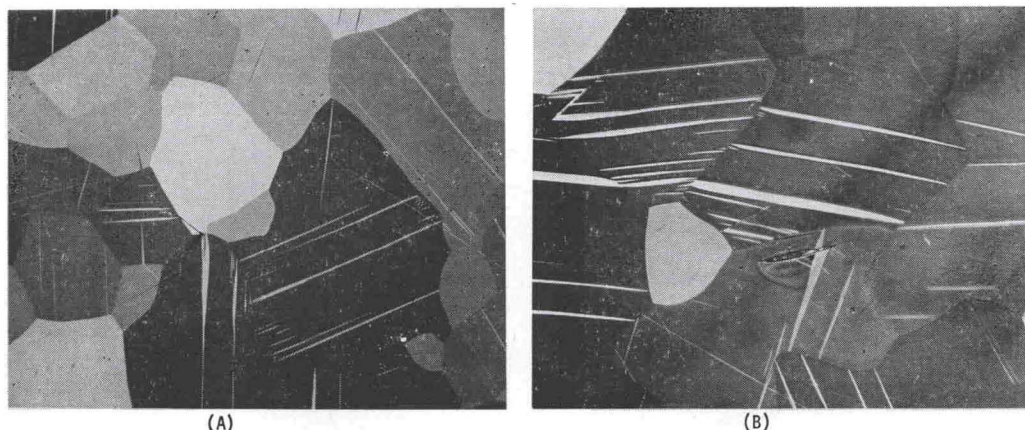
FIG. 5. The microstructure of a pure bismuth specimen tested to failure at atmospheric pressure showing: (a) Cracks formed by the intersection of twins with grain boundaries (75 \times , Unetched, Polarized Light), and (b) Twin-crack pairs felt to nucleate below the plane of polish by the mechanism outlined in Fig. 6. (100 \times , Unetched, Polarized Light).

FIG. 6. A schematic representation of the appearance of cracks without metallographically observed obvious means of nucleation. The plane of polish intersects the crack above the point of nucleation, and results in the structures seen in Fig. 5(b).

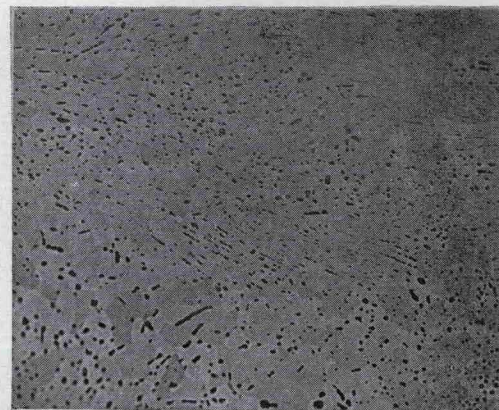
FIG. 9(b). The microstructure of a 90% Sn-bal Bi specimen where pressure at fracture equalled $1.55 \times 10^8 \text{ N/m}^2$. Note the smaller grain size than that shown by Fig. 9 (a) and lack of particle-matrix separation. 500 \times , Unetched.
