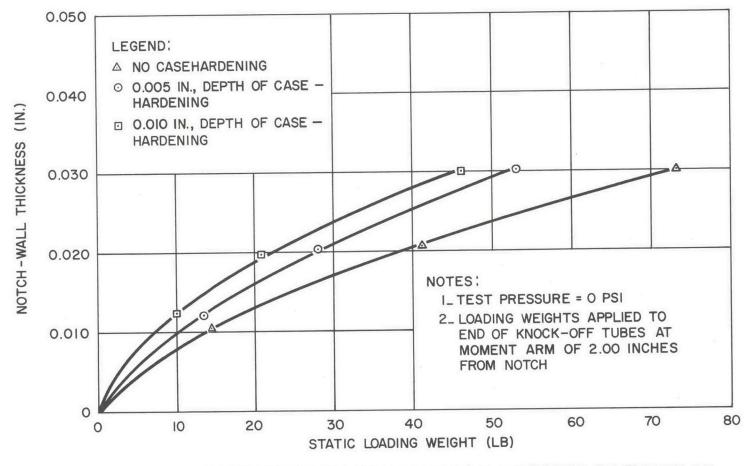
FIG. 23 EFFECTS OF CASEHARDENING AND NOTCH-WALL THICKNESS ON FAILURE OF 3/8"O.D. (1/8"I.D.) TUBES SUBJECTED TO STATIC LOADS

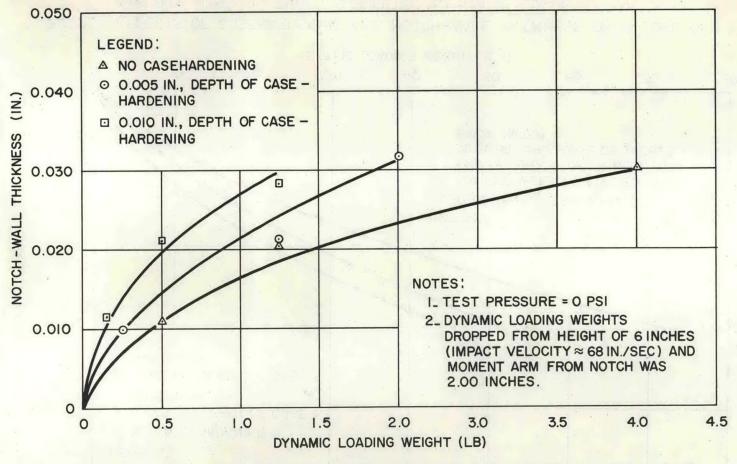
FIG. 24 EFFECTS OF CASEHARDENING AND NOTCH-WALL THICKNESS ON FAILURE OF 3/8" O.D. (1/8" I.D.) TUBES SUBJECTED TO DYNAMIC LOADS
