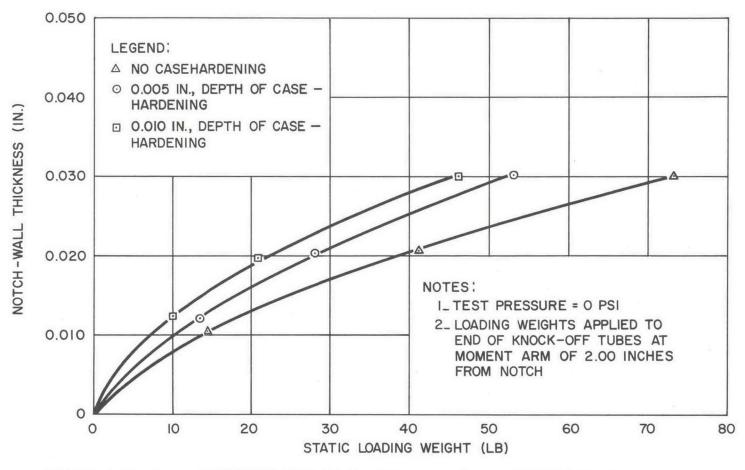
FIG. 23 EFFECTS OF CASEHARDENING AND NOTCH-WALL THICKNESS ON FAILURE OF 3/8" O.D. (1/8" I.D.) TUBES SUBJECTED TO STATIC LOADS

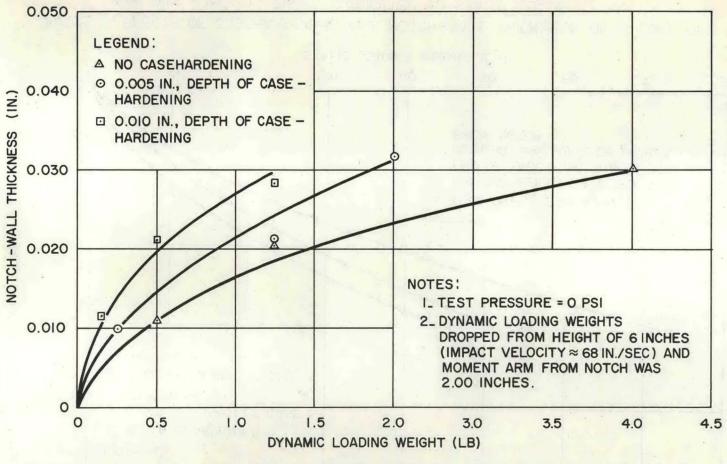
FIG. 24 EFFECTS OF CASEHARDENING AND NOTCH-WALL THICKNESS ON FAILURE OF 3/8"O.D. (1/8"I.D.) TUBES SUBJECTED TO DYNAMIC LOADS
