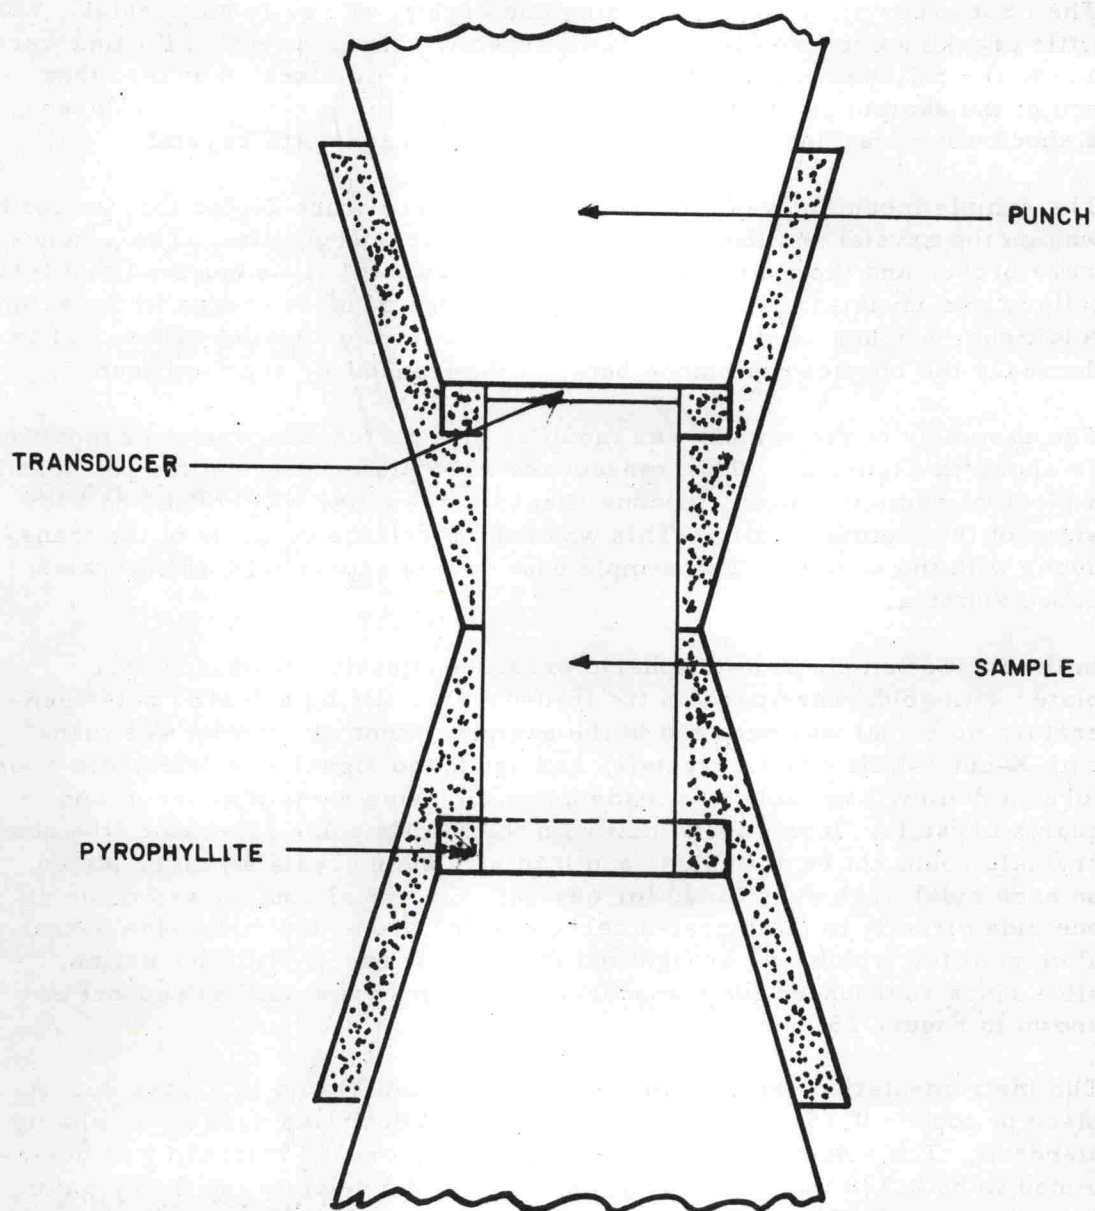
Figure 24 SAMPLE DETAIL PRELIMINARY TESTS

The sample mounting was modified, as shown in Figure 24, so that the load was on the crystal and the sample and not in the pyrophyllite. The punches were broken and the quartz transducer was crushed. It is believed that this failure was initiated by undetected cracks in the punches and/or in the sample. Additional punches used for these measurements were plated with nickel to decrease the contact resistance between the transducer and the punches.
