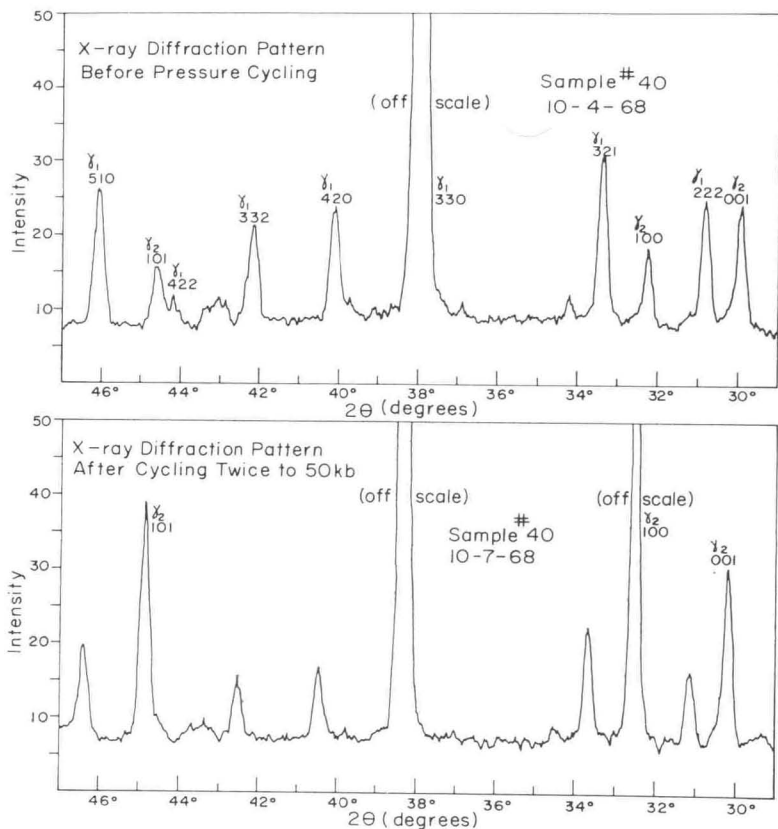
FIG 2.—*Top*, X-ray diffraction pattern of dental amalgam before application of pressure. Diffraction peaks corresponding to γ_1 (Ag_2Hg_3) and γ_2 (HgSn_{7-8}) are labeled. *Bottom*, X-ray diffraction pattern of the same amalgam immediately after the application of 50 kb pressure shows an increase in intensities of γ_2 peaks, which corresponds to reorientation or recrystallization of γ_2 crystals. Surfaces of sample were removed by grinding; thus, X-ray diffraction patterns correspond to internal amalgam structure.

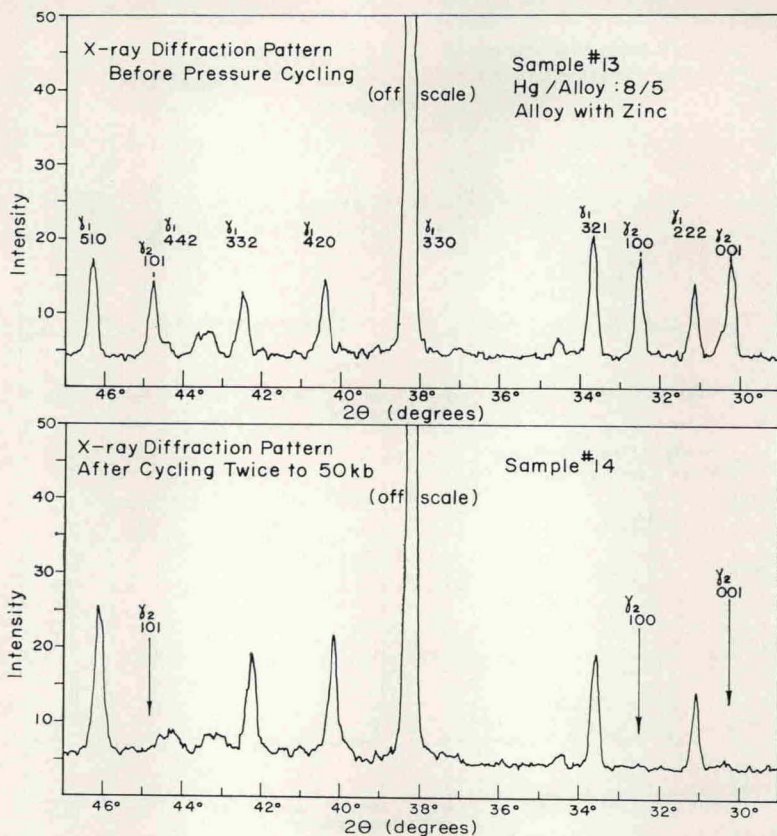
FIG 3.—*Top*, X-ray diffraction pattern of amalgam before application of pressure. Sample contained mercury-to-alloy ratio of 8:5, alloy contained zinc. *Bottom*, X-ray diffraction pattern of identical sample shows γ_2 peaks have disappeared six months after cycling twice to 50 kb. There is no evidence of formation of new phase.
