Figure A-9 VISUALLY OBSERVED RING IMPERFECTIONS

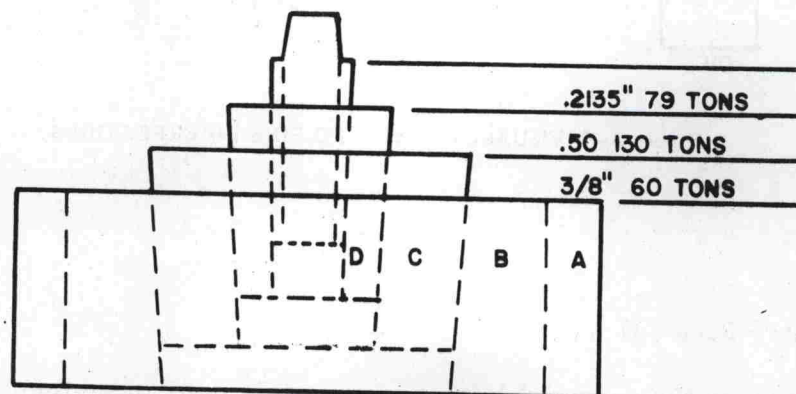
Figure A-10 PUNCH ASSEMBLY NUMBER 1

Punch No. 1 Outer Ring (A)

This ring has two fine lines as shown by arrows 1 and 2. These lines, as well as the spot No. 3, are not scratches or notches made after machining. They appear to have been there before machining. However No. 1 is a fine line $\frac{5}{16}$ inch long, No. 2 is $\frac{1}{32}$ inch wide and $\frac{7}{32}$ inch long, and No. 3 is $\frac{1}{32}$ inch wide by $\frac{3}{8}$ inch long.

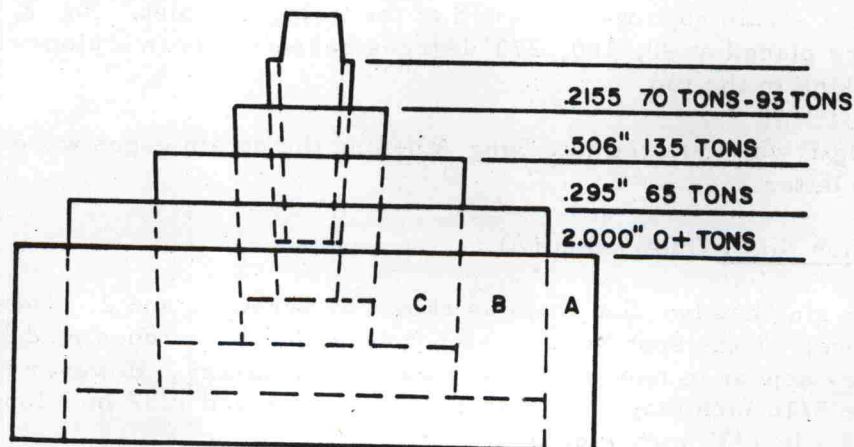
Figure A-11 PUNCH ASSEMBLY NUMBER 2

Punch No. 2 Outer Ring (A)

The outer ring has a notch at approximately 45 degrees from its axis. The notch measures $\frac{7}{16}$ inch long, $\frac{1}{4}$ inch wide, and no more than 0.003 inch deep. A strain gage was mounted at 0 degrees near the notch and three others at 90, 180, and 270 degrees from the first one.

Note: The above diagrams show (schematically) the interference between each of the Punch elements, and the corresponding force required to assemble each element.
