Figure A-9 VISUALLY OBSERVED RING IMPERFECTIONS

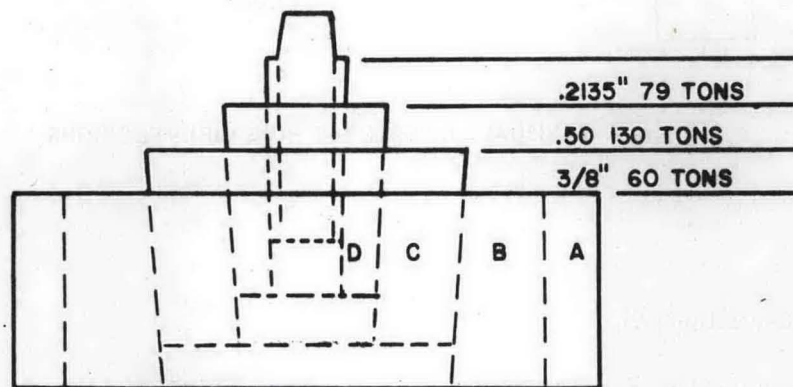
Figure A-10 PUNCH ASSEMBLY NUMBER 1

This ring has two fine lines as shown by arrows 1 and 2. These lines, as well as the spot No. 3, are not scratches or notches made after machining. They appear to have been there before machining. However No. 1 is a fine line  $5/16$  inch long, No. 2 is  $1/32$  inch wide and  $7/32$  inch long, and No. 3 is  $1/32$  inch wide by  $3/8$  inch long.

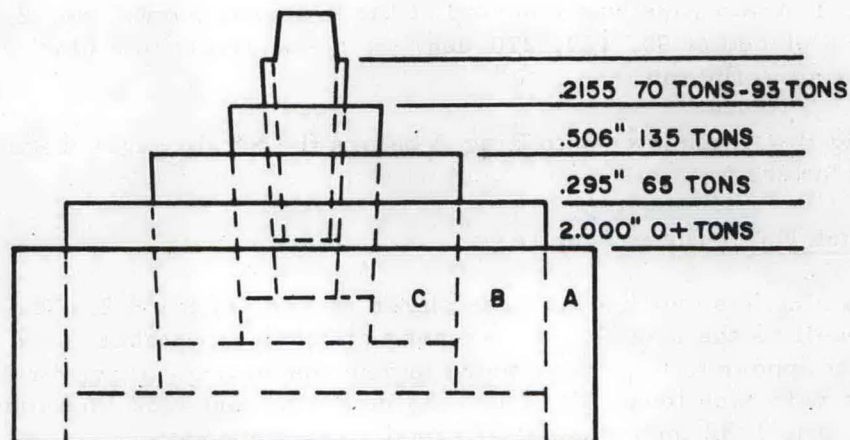
Figure A-11 PUNCH ASSEMBLY NUMBER 2

The outer ring has a notch at approximately 45 degrees from its axis. The notch measures  $7/16$  inch long,  $1/4$  inch wide, and no more than 0.003 inch deep. A strain gage was mounted at 0 degrees near the notch and three others at 90, 180, and 270 degrees from the first one.
