Fault Planes in Steam-Oxidized Silicon

F. J. WILHELM AND M. L. JOSHI

Systems Development Division, International Business Machines Corporation, Poughkeepsie, New York

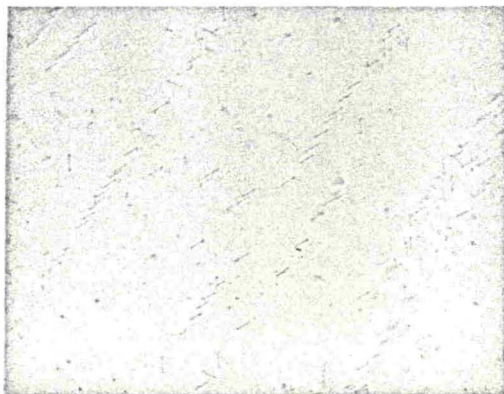
FIG. 1. Dash-etched line faults (taken at $\times 650$, shown here $\times 455$).

damage. Chemical etching showed less than 5×10^3 etch pits/cm². Some of these slices were vacuum-annealed at 1000°C for 45 min. Neither Dash etch nor the electron microscope revealed significant defects. The annealed wafers were then steam-oxidized at 1150°C for 45 min. The oxide layer grown was about 0.7 μ thick. After removal of the oxide and after application of Dash etch for about 5 min, etch markings became visible, as shown in Fig. 1. Lines bounded on both sides by etch pits are oriented to maintain 60° angles between each other and delineate the (110) directions, and are of rather uniform length. Often, the lines are arranged in long rows that can be followed over several hundred microns. The rows are often parallel to each other and do not seem to lie in particular low-indexed crystallographic directions. The lines have a limited depth; they disappear after being subjected to the Dash etch for ~ 8 min, removing $\sim 1\frac{1}{2}$ μ of silicon. On wafers of 12-mil thickness (which showed etch markings on both sides), no correspondence of row directions or pit densities on the two sides was detected.

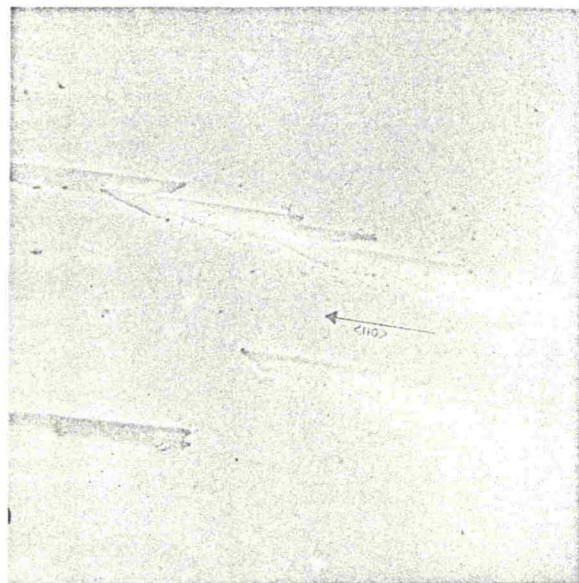
FIG. 2. Electron micrograph of stacking faults; note impurities bounding the faults; taken at $\times 19\,000$, shown here $\times 7600$.

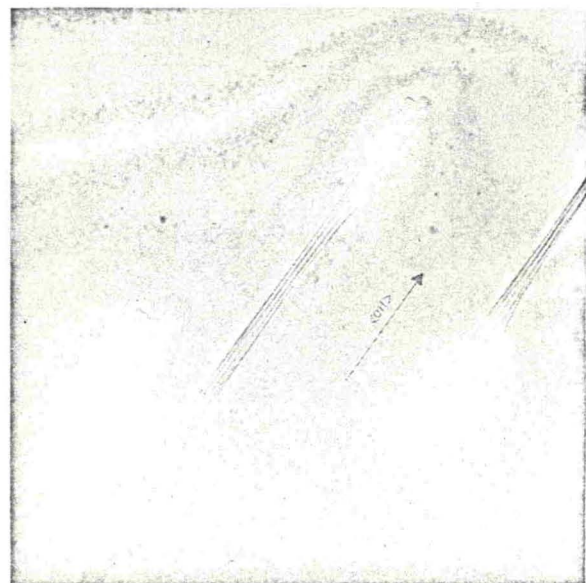
FIG. 3. Electron micrograph of ends of stacking faults; taken at $\times 52\,000$, shown here $\times 20\,800$.
