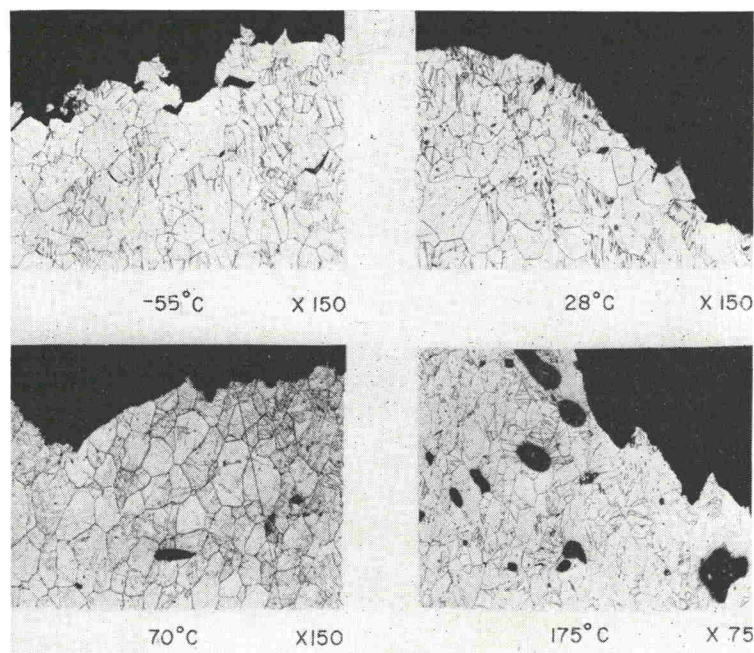
FIG. 5. Microstructure of magnesium near fracture surface at various temperatures, atmospheric pressure.

cavities which either linked together or reduced the actual load carrying cross-section to the point where rupture occurred.
