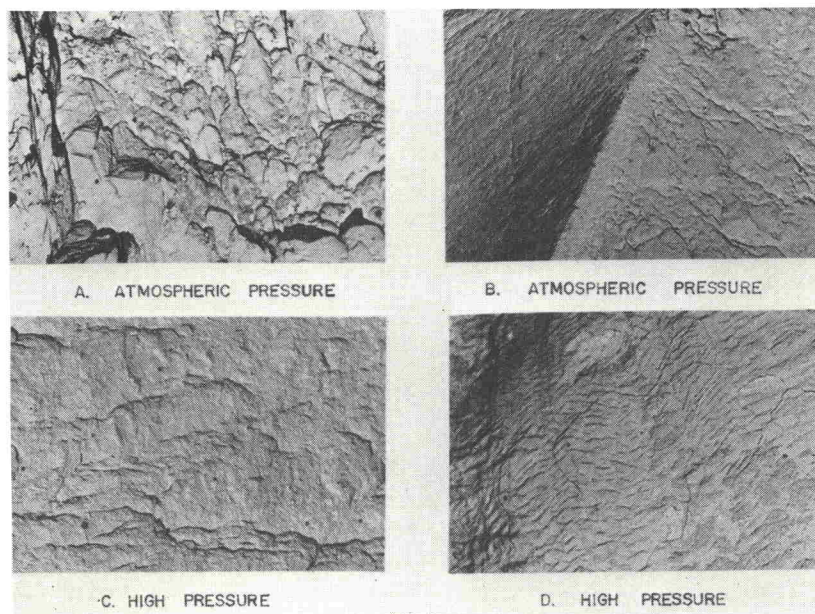
FIG. 9. Electron fractographs of magnesium fractured at  $-55^{\circ}\text{C}$ .  $\times 6,500$

characteristic of normal ductile fracture. Dimples are associated with voids, thus one can deduce that since no dimples occur, the superposed hydrostatic pressure has prevented the formation of voids.
