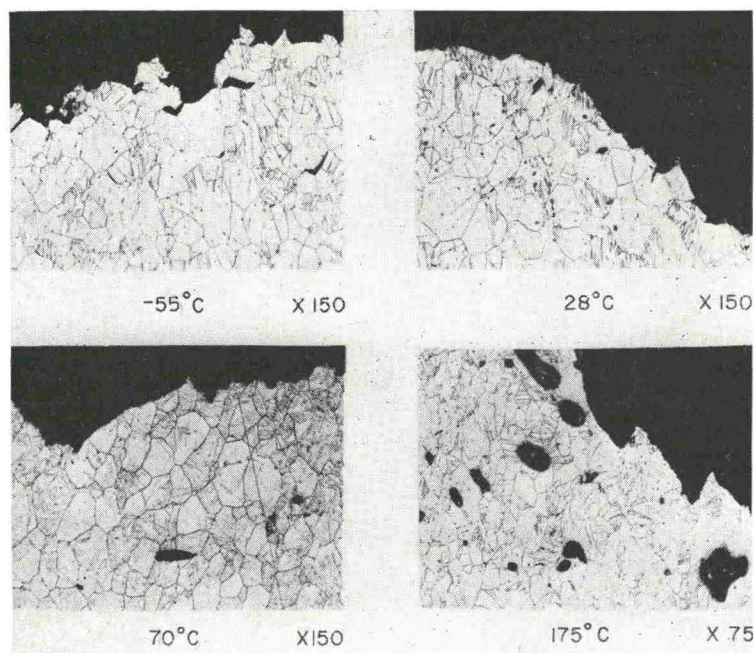
FIG. 5. Microstructure of magnesium near fracture surface at various temperatures, atmospheric pressure.

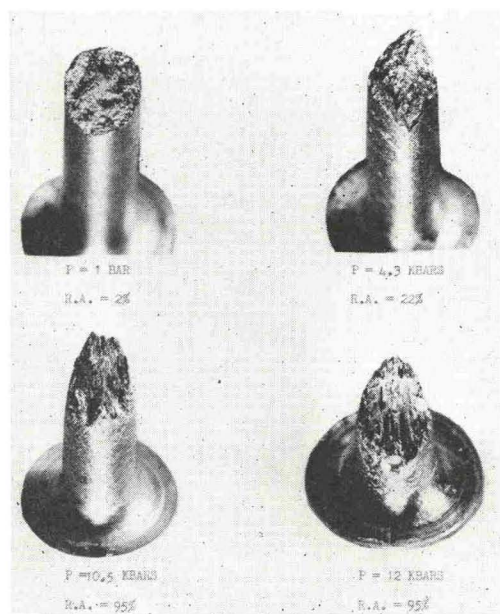
FIG. 6. Fracture appearance of magnesium as a function of pressure at -55°C .

Low temperature. The macroscopic fracture appearance for magnesium, as a function of pressure at -55°C , is shown in Fig. 6. Initially, one sees a

progressive increase in the amount of necking along with a retardation of the brittle fracture appearance and finally the onset of shear and fibrous fracture. The abrupt discontinuity in ductility shown in Fig. 3 corresponds to the fracture appearance connecting to the shear or gliding type along the shear plane as shown in the latter two photographs of Fig. 6. Above the transition pressure, no further change in fracture appearance occurred. At room temperature, the fracture appearance was much the same as at -55°C .
