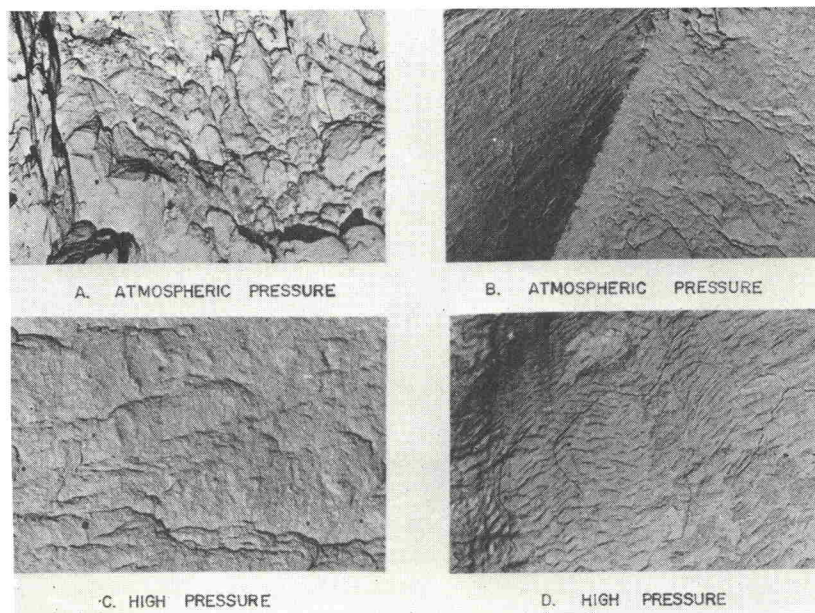
FIG. 9. Electron fractographs of magnesium fractured at -55°C . $\times 6,500$

characteristic of normal ductile fracture. Dimples are associated with voids, thus one can deduce that since no dimples occur, the superposed hydrostatic pressure has prevented the formation of voids.
