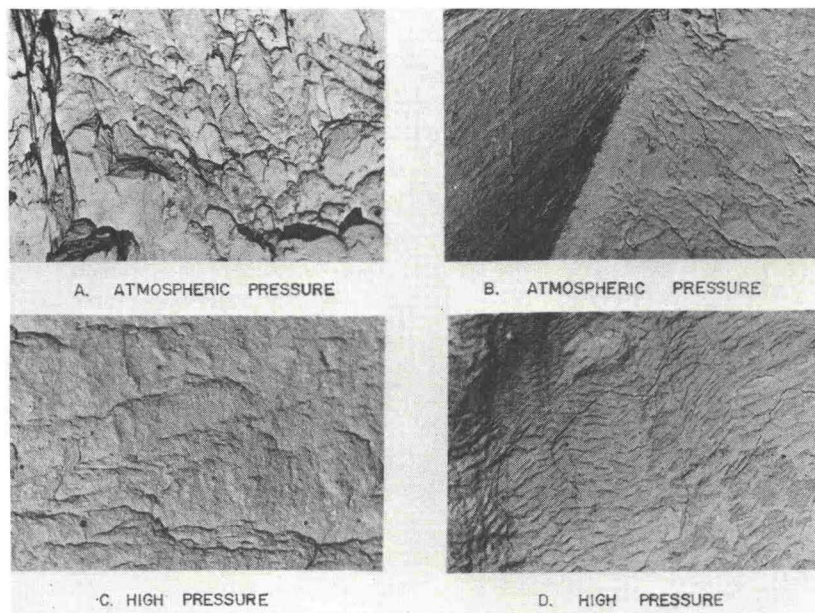
Fig. 9. Electron fractographs of magnesium fractured at -55°C . $\times 6,500$

characteristic of normal ductile fracture. Dimples are associated with voids, thus one can deduce that since no dimples occur, the superposed hydrostatic pressure has prevented the formation of voids.
