#### *Tin-bismuth alloys*

#### *90 per cent Sn-bal Bi alloy*

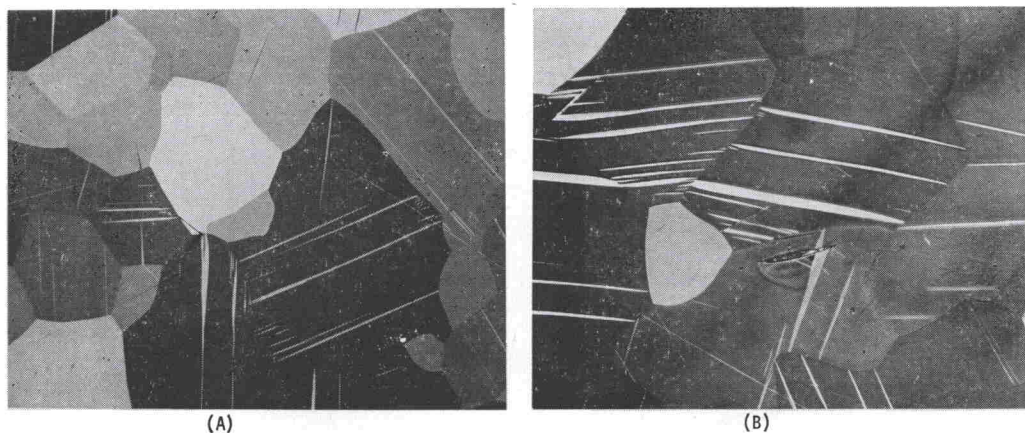
FIG. 5. The microstructure of a pure bismuth specimen tested to failure at atmospheric pressure showing: (a) Cracks formed by the intersection of twins with grain boundaries (75 $\times$ , Unetched, Polarized Light), and (b) Twin-crack pairs felt to nucleate below the plane of polish by the mechanism outlined in Fig. 6. (100 $\times$ , Unetched, Polarized Light).

FIG. 6. A schematic representation of the appearance of cracks without metallographically observed obvious means of nucleation. The plane of polish intersects the crack above the point of nucleation, and results in the structures seen in Fig. 5(b).

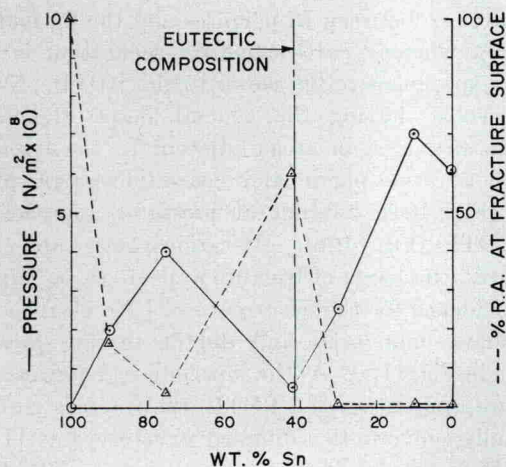
FIG. 8. The variation in ductility and ductility transition pressure as a function of composition.

The trend in ductility exhibited by various Sn-Bi alloys compositions at atmospheric pressure and the variation in transition pressure of these compositions is shown in Fig. 8. Ductility is seen to be a maximum

for pure tin and for near-eutectic compositions with small Bi additions severely lowering the ductility of the high Sn alloys. Comparison of the two curves shows a direct relationship to exist between the effects of pressure and composition on ductility. Those areas having high ductility (pure Sn and near-eutectic compositions) correspond to the low transition pressures, and compositions having a low inherent ductility required a higher value of superimposed hydrostatic pressure in order to fail by rupture.

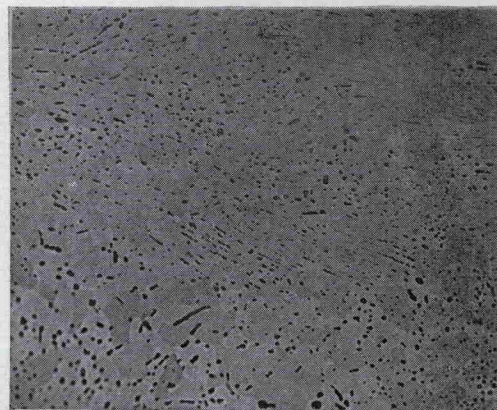
FIG. 9(b). The microstructure of a 90% Sn-bal Bi specimen where pressure at fracture equalled  $1.55 \times 10^8 \text{ N/m}^2$ . Note the smaller grain size than that shown by Fig. 9 (a) and lack of particle-matrix separation.  $500\times$ , Unetched.
