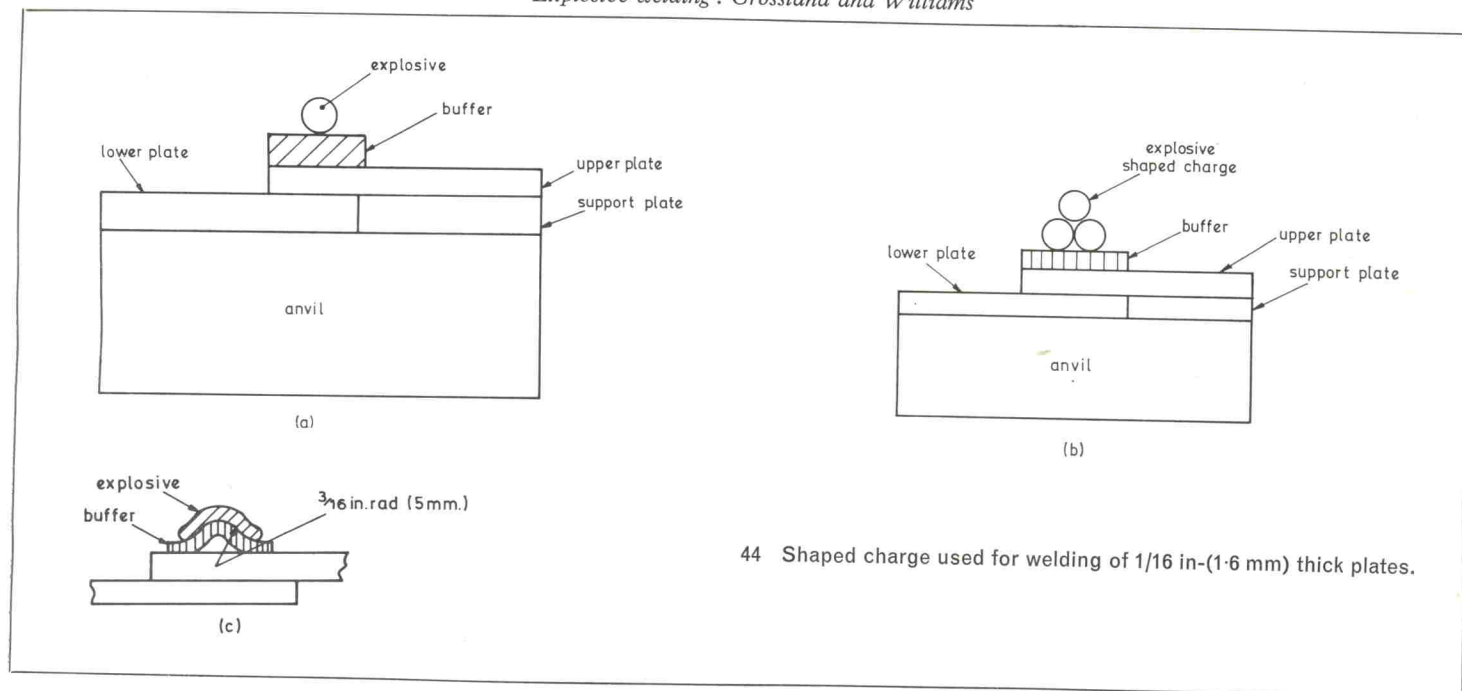
44 Shaped charge used for welding of 1/16 in-(1.6 mm) thick plates.

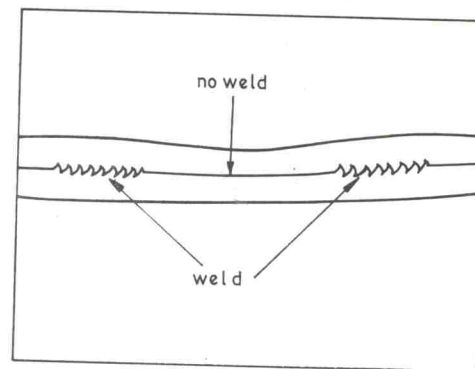
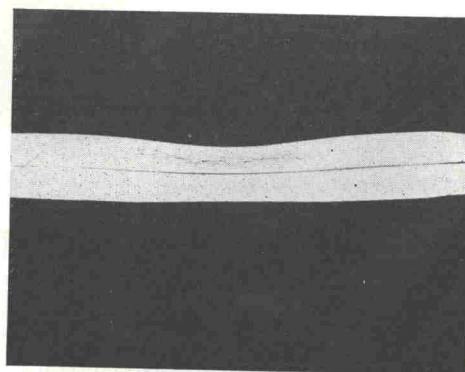
45 Seam weld in brass sheet made with Cordtex. (a) Form of interface under the line charge; (b) micrograph of interface in the region of the line charge.  $\times 1\frac{1}{4}$ .
