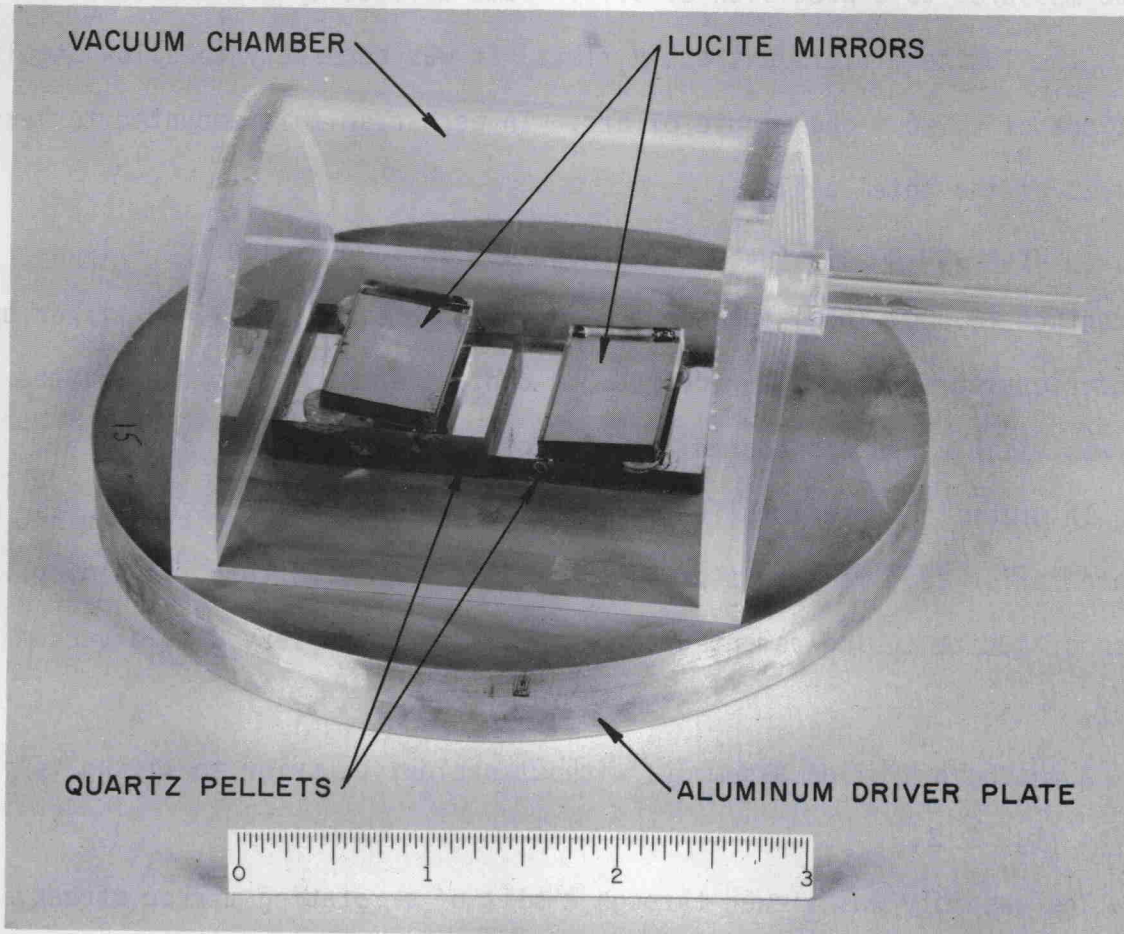
A photograph of an assembly, without explosive, prior to firing is shown as Fig. 2.2.

**Fig. 2.2.--Photograph of Experimental Assembly**

In order to obtain the desired accuracy in shock velocity,  $\pm$  1%, good contact (0.0002 inch) between the inside edge of the inclined mirror and the outer quartz surface was required. A contact such that no transmitted light was visible was considered satisfactory.

In order to avoid complications due to air shocks the assembly was evacuated prior to firing to a pressure of less than 0.05 torr. A hemicylindrical section of lucite tubing cemented to the aluminum plate served as a vacuum chamber.
